# REPORT 448/25-560-1-EN

About performance comparison of lightweight noncombustible sheet in rooftop PV-related fires

Orderer: Allshield holding BV

Date: 1. 8. 2025

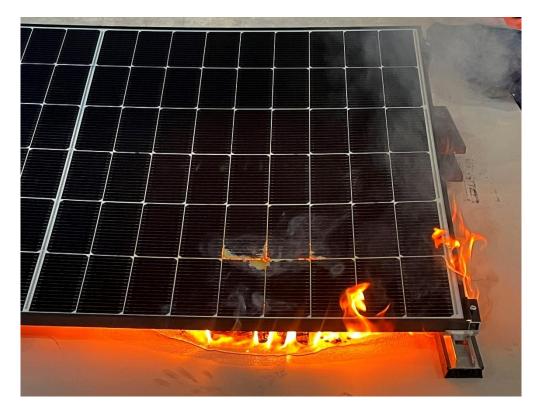
Flames emerged from the right edge of the PV module at 2 minutes and from the bottom edge by minute 3. Between minutes 3 and 4, delamination of solar cells was observed above the position of the ignition source (Figure 8). By 4.5 minutes, flames reached the upper edge, while at 7 minutes, they extended to the left edge of the module (Figure 9). At 7.5 minutes, the membrane ignited outside the PV module area, starting from the right side. White smoke, considered to be water steam, began emerging from beneath the AllShield BarrierSheet shortly thereafter (Figure 10). At 12 minutes, the PV glass shattered, with the fire largely contained under the module area (Figure 11). By minutes 21–22, only a few small flames remained beneath the PV module. The test finished at 30 minutes with the extinguishment of the final residual flames, while the progression of the fire throughout the test can be seen in the video snapshots shown in Figure 12 and Figure 13.

Figure 8 Sample AS-1 Initial fire spread - flames coming out from the short edge of the panel, delamination of solar cells, burning of membrane (4 min after ignition) (FotoPortal 050524d-002)

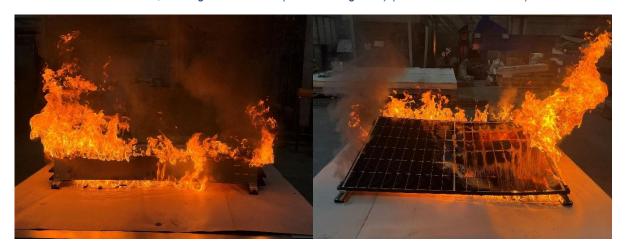
Figure 9 Sample AS-1 The extent of fire after 7 min - back (left) and front (right) view (FotoPortal (left 050524d-004, right 050524d-006))

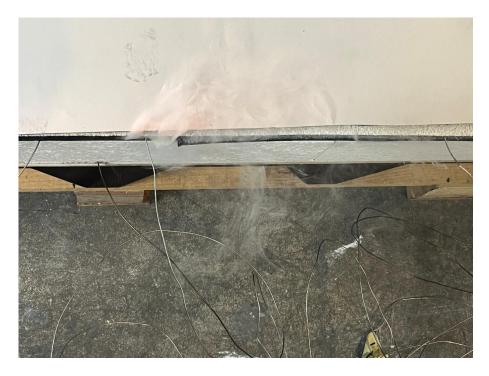
Figure 10 Sample AS-1 White smoke emerging from below the AllShield BarrierSheet (FotoPortal 050524d-007)

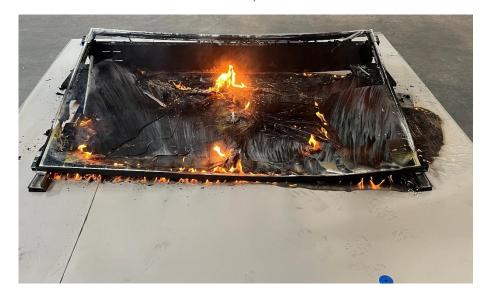
Figure 11 Sample AS-1 PV glass shattered after 12 min - fire was contained under the PV area, except on the side of the ignition source (FotoPortal 050524d-010)

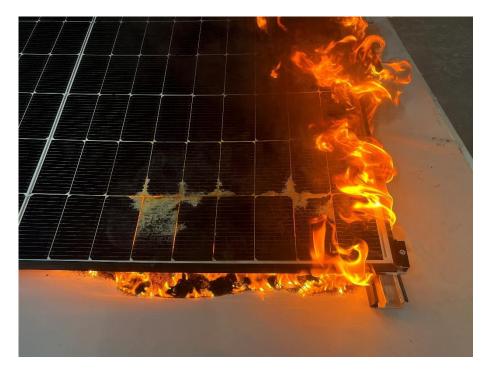
Figure 14 Sample AS-2 Initial fire spread - flames spread under the right edge of the panel, delamination of solar cells, burning of the membrane (5 min after ignition) (FotoPortal 050524d-033)

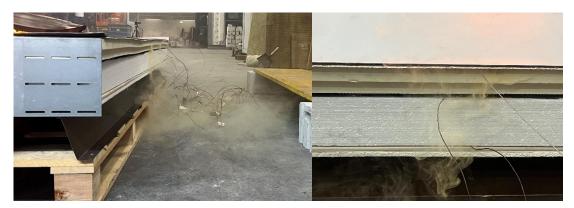
Overall, the fire development and extent of visible damage were similar to the test AS-1. However, the appearance of yellow smoke from the PIR boards indicated different combustion behaviour. Unlike in the first test, the PV glass did not shatter, influencing airflow and energy dynamics beneath the panel.

Figure 15 Sample AS-2 Yellow smoke from under the AllShield BarrierSheet at 10 min - side view (left), close-up (right) (FotoPortal (left 050524d-035, right 050524d-037))

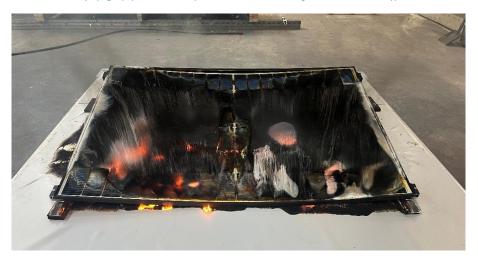
Figure 16 Sample AS-2 Minimal damage outside of PV module area (16 min) (FotoPortal 050524d-039)

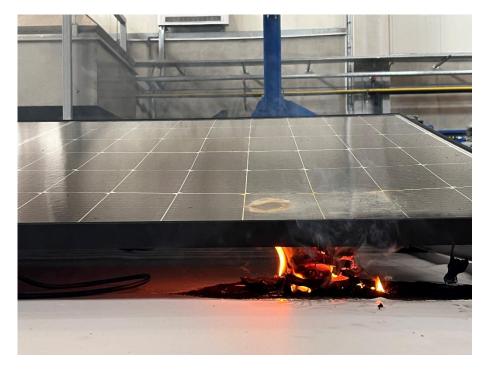
In the initial test, no flame spread was observed, and sample self-extinguished after 8 minutes (Figure 19). Damaged parts were exchanged with new materials, and test was repeated with two wood cribs.

Figure 19 Sample AS-3 First try with one wood crib – no flame spread beyond the area of the crib (FotoPortal 050524d-065)

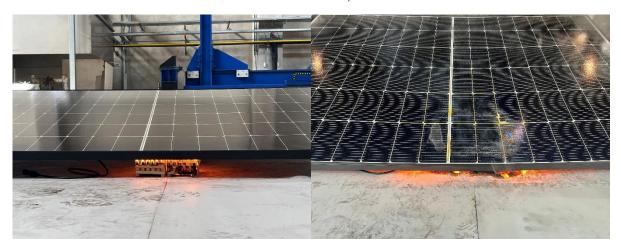
Figure 20 Sample AS-3 Larger wood crib at the ignition (left) and the deformation of the PV module 4 minutes after the ignition (right) (FotoPortal (left 050524d-067, right 050524d-070))

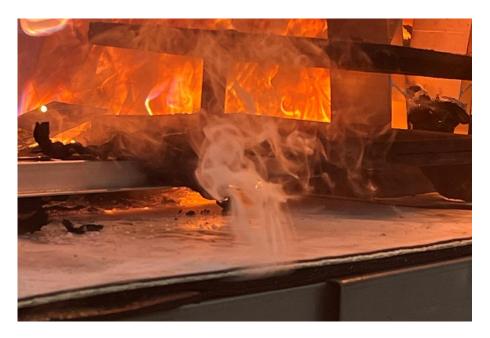
Figure 21 Sample AS-3 Water steam coming from under the membrane (FotoPortal 050524d-071)

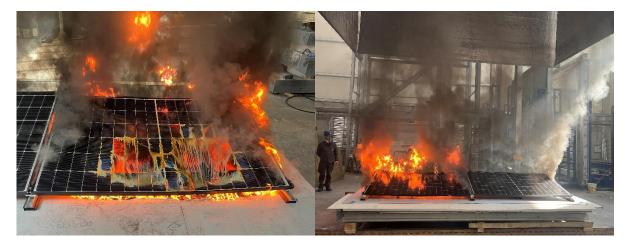
Figure 22 Sample AS-3 State of flame spread 10 minutes after the ignition - front view (left) and rear view (right) (FotoPortal (left 050524d-073, right 050524d-076))

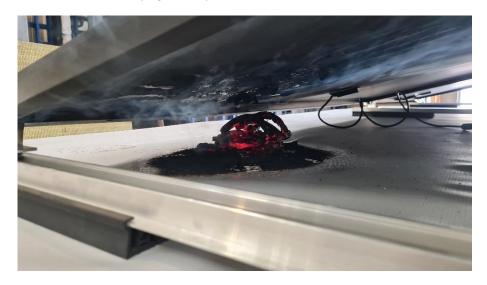
The first test was performed with one wood crib. The test resulted in no fire spread and self-extinguished within 8 minutes (Figure 25).

Figure 25 Sample AS-4 First test with one wood crib - fire self-extinguished without propagation (FotoPortal 050524d-102)

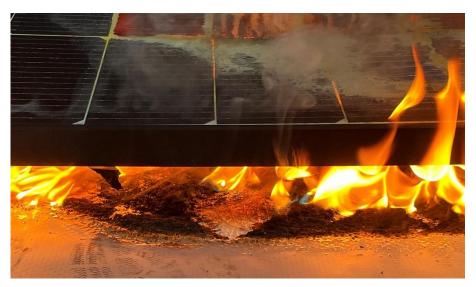
Figure 27 Sample AS-4 Close-up of burned membrane (6 min) (FotoPortal 050524d-106)

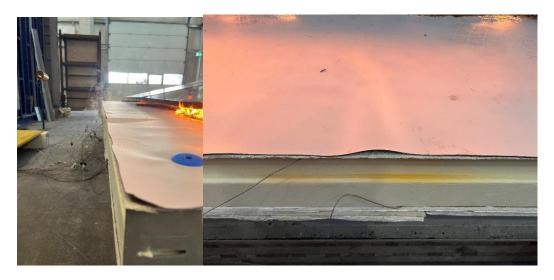
Figure 28 Sample AS-4 Yellow smoke from PIR boards (left – 7 min) and discolouration on PIR boards (right – 12 min) at the front side of the specimen (FotoPortal (left 050524d-108, right 050524d-110))

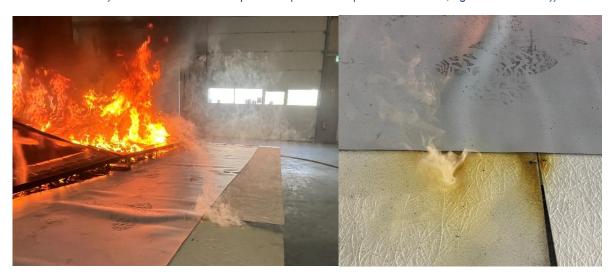
Figure 29 Sample AS-4 Combination of yellow smoke and water steam (left) along with yellow stain on the AllShield BarrierSheet (right - 18 min) at the rear side of the specimen (FotoPortal (left 050524d-112, right 050524d-114))

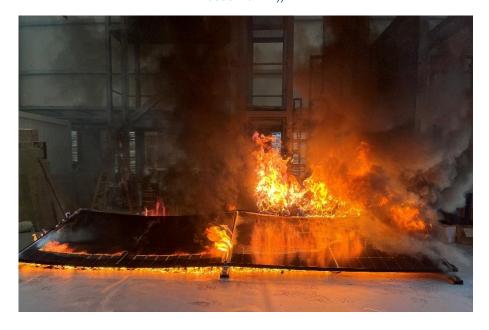
Figure 30 Sample AS-4 Fire spread 16 min after the ignition (FotoPortal 050524d-116)

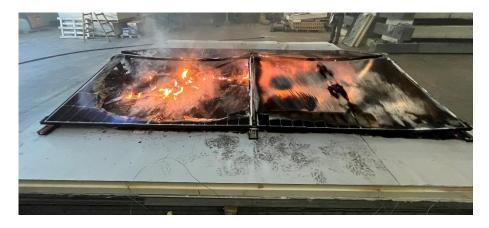
Figure 31 Sample AS-4 Fire subdued and 3rd PV module shattered due to cooling down (23 min) (FotoPortal 050524d-118)

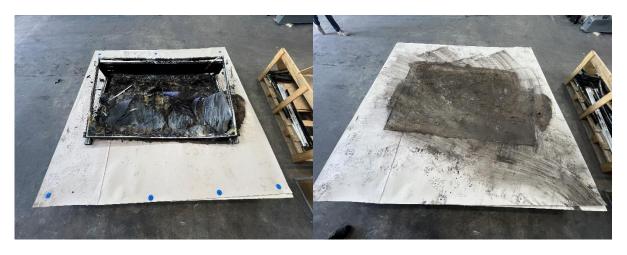
Visual inspection after the test revealed that most of the fire damage was concentrated directly beneath the PV modules. As shown in Figure 41, removal of the modules exposed clear burn patterns, with the most severe degradation occurring in the central area of the specimen. The membrane exhibited a distinct edge of fire propagation and showed visible shrinking in areas exposed to elevated temperatures (Figure 42).

Figure 41 Sample AS-1 after the test with (left) and without (right) the PV module (FotoPortal (left 050524d-158, right 050524d-160))

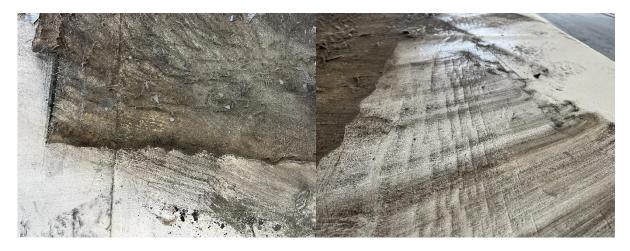
Figure 42 Sample AS-1 Close-up of membrane showing edge of fire propagation (left) and shrinking due to heat exposure (right) (FotoPortal (left 050524d-161, right 050524d-164))

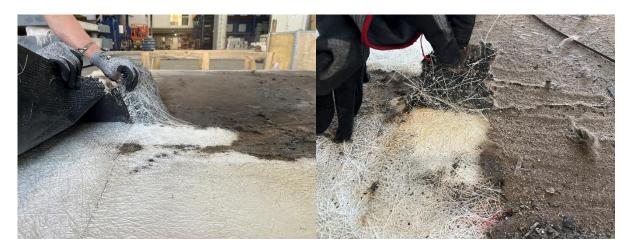
Beyond the actively burned zone, the membrane had partially bonded to the AllShield BarrierSheet due to heat exposure, causing peeling of its top layer during removal (Figure 43). In the underlying layers, the bitumen showed localised delamination where the bottom side of the AllShield BarrierSheet had adhered to it during the test (Figure 44).

Figure 43 Sample AS-1 outside of the burned area, the membrane got stuck to the AllShield BarrierSheet (left), peeling off the top layer and the state of the AllShield BarrierSheet below the affected part (right) (FotoPortal (left 050524d-165, right 050524d-168))

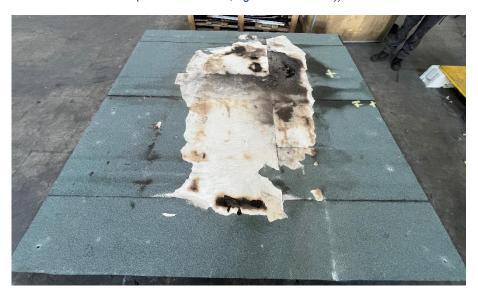
Figure 44 Sample AS-1 Bitumen top layer after removal of AllShield BarrierSheet. The bottom side of the AllShield BarrierSheet got stuck to the bitumen layer below the burned area (FotoPortal 050524d-170)

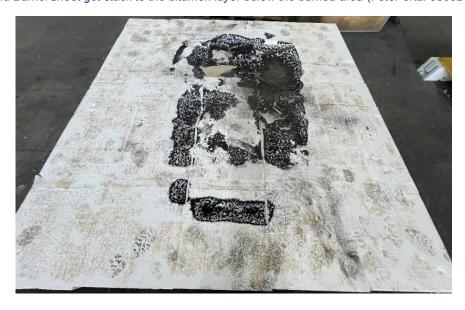
Although the flame did not breach the AllShield BarrierSheet, thermal transfer still affected deeper components. In several spots, the EPS insulation layer beneath the burned area melted entirely, with the full 10 cm thickness consumed by heat (Figure 45). Overall, the barrier system prevented flame penetration, and most of the damage can be attributed to heat transfer rather than direct flame exposure.

Figure 45 Sample AS-1 The EPS layer melted under the burned area below the PV modules (FotoPortal 050524d-172)

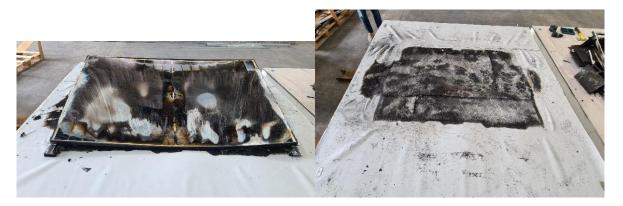
Figure 46 Sample AS-2 after the test with (left) and without (right) the PV module (FotoPortal (left 050524d-174, right 050524d-175))

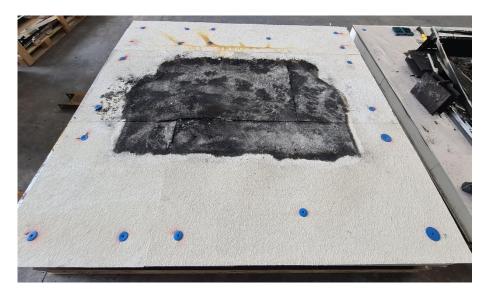
Figure 47 Sample AS-2 Overview of AllShield BarrierSheet layer (FotoPortal 050524d-178)

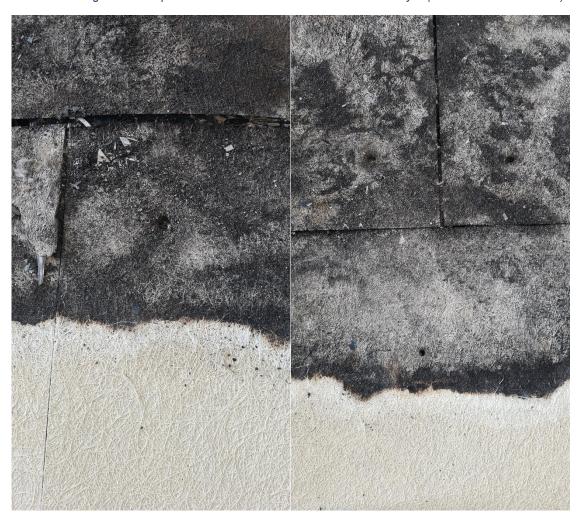
As shown in Figure 46, removal of the PV modules exposed the burned surface, with visible degradation directly beneath the module area. The AllShield BarrierSheet layer (Figure 47) exhibited localised burn-through and gaps between adjacent boards (Figure 48), which may have facilitated localised heat transfer. Beneath the barrier, the PIR insulation layer showed the most prominent signs of damage (Figure 49). Close-up views revealed destruction of the upper aluminium foil and deformation along board edges under the most intense heat exposure (Figure 50 - left). Outside the main burned area, a yellow-brown, greasy deposit was left on the PIR surface — a residue from some sort of thermal decomposition of PIR (Figure 50 - right), similar in colour to observed yellow smoke during the test.

Figure 48 Sample AS-2 Closer look at two places (left and right) with burned area and gaps between the boards (FotoPortal (left 050524d-180, right 050524d-182))

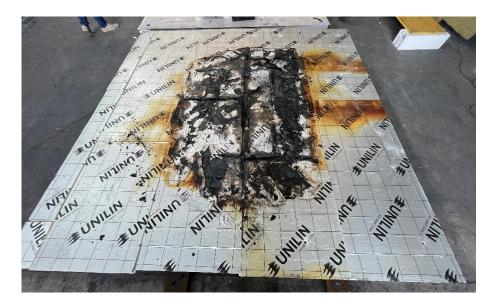
Figure 49 Sample AS-2 PIR layer after the test (FotoPortal 050524d-184)

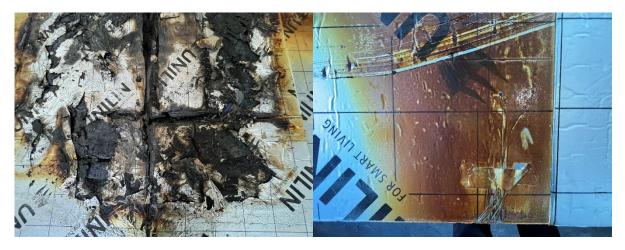
Figure 50 Sample AS-2 Closer look at the PIR - destroyed upper aluminium layer and deformation at the edges of the boards below the burning area (left) and yellow-brown greasy deposit outside the burning area (right) (FotoPortal (left 050524d-186, right 050524d-188))

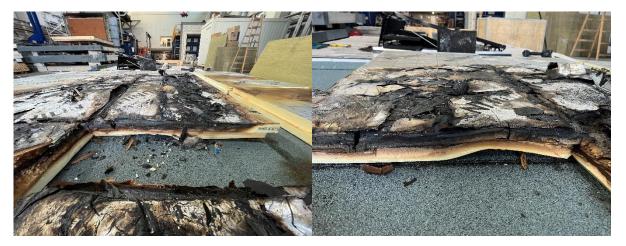
A side view of the PIR board joints (Figure 51) highlights how these junctions were affected by heat. In particular, the central PIR board experienced severe deformation – buckling - (Figure 52), likely due to a combination of thermal stress and mechanical constraint from anchoring elements. As the heat acted on the anchored points, the board warped considerably. Below this layer, the bitumen membrane showed no significant thermal degradation, although the greasy residue from the PIR layer penetrated through the PIR joints and stained the bitumen locally (Figure 53 - left). The EPS layer also remained mostly intact, aside from slight discolouration and minor deformation directly beneath the ignition source (Figure 53 - right; Figure 54). These signs confirm that while the barrier system prevented flame penetration, heat conduction and the release of volatile compounds from PIR still caused visible, though limited, damage in the deeper layers.

Figure 51 Sample AS-2 Side view of PIR board joints showing damage by the heat to the PIR boards (left) and also some buckling of PIR (right) (FotoPortal (left 050524d-190, right 050524d-192))

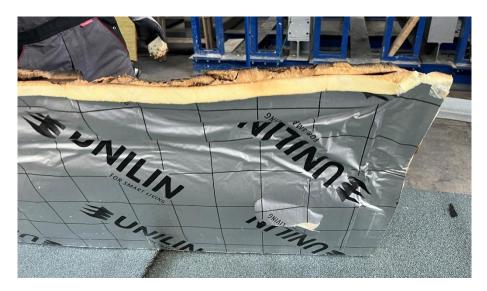
Figure 52 Sample AS-2 Deformation of the middle PIR board (FotoPortal 050524d-194)

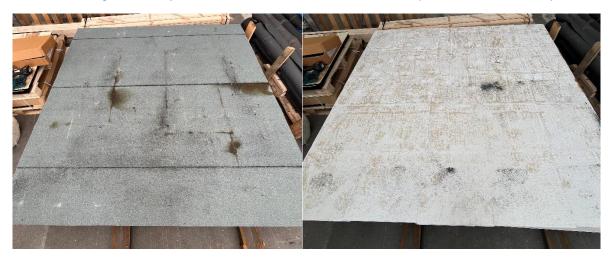
Figure 53 Sample AS-2 Overview of bitumen (left) and EPS (right) layers showing some discolouration (FotoPortal (left 050524d-196, right 050524d-198))

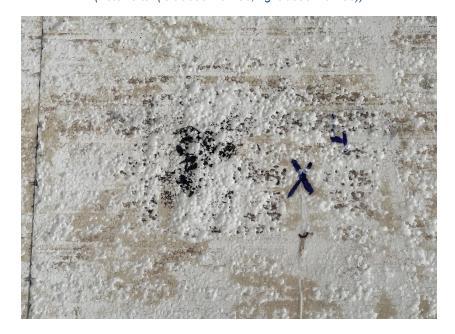
Figure 54 Sample AS-2 Damage to the EPS layer directly under the ignition source (black spots indicate melting of bitumen above the EPS) (FotoPortal 050524d-200)

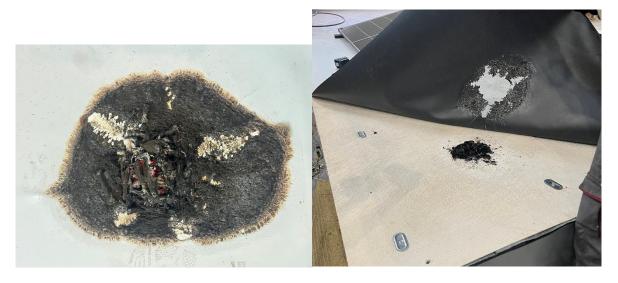
The fire in the first test self-extinguished without propagating. Damage was localised under the ignition source. As shown in Figure 55, the membrane and the AllShield BarrierSheet sustained surface damage in the ignition area.

Figure 55 Sample AS-3 First test with a single enlarged wood crib - damage on membrane (left) and AllShield BarrierSheet (right) (FotoPortal (left 050524d-202, right 050524d-204))

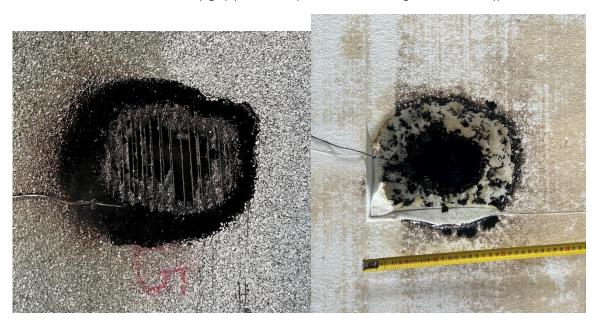
More notably, despite the small, affected area (approximately 20 cm<sup>2</sup>), the damage extended through all layers down to the EPS insulation. As shown in Figure 56, the bitumen and the EPS beneath the ignition point had completely melted. This localised burn-through required the full replacement of the damaged section before the next test could be carried out.

Figure 56 Sample AS-3 First test with a single enlarged wood crib - damage on bitumen (left) and EPS (right) (FotoPortal (left 050524d-206, right 050524d-208))

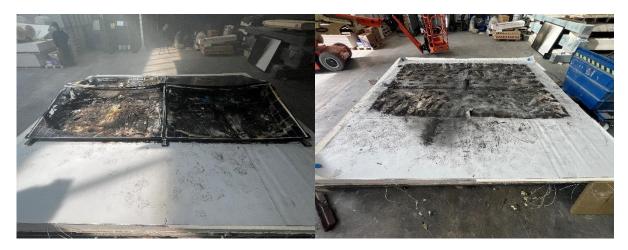
After the test, removal of the PV modules revealed concentrated fire damage beneath the burned area, as shown in Figure 57. The membrane burned through completely in several places (Figure 58). Beneath this, the bitumen layer showed significant degradation and traces of the AllShield BarrierSheet fused to its surface in areas directly affected by fire (Figure 59).

Figure 57 Sample AS-3 Specimen after the test with (left) and without (right) the PV modules (FotoPortal (left 050524d-210, right 050524d-212))

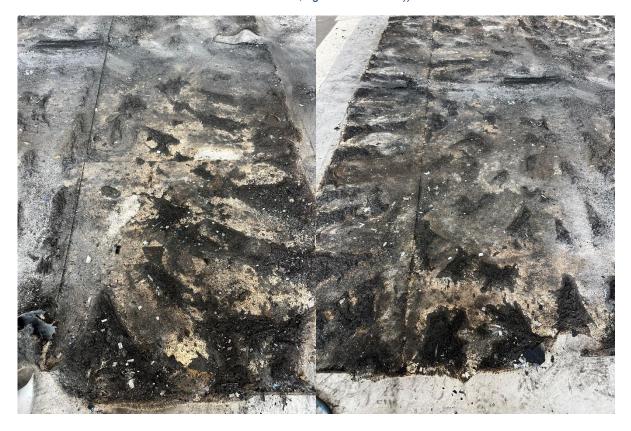
Figure 58 Sample AS-3 A closer look at the membrane, showing two close-ups (left and right) of AllShield BarrierSheet under the burnt areas (FotoPortal (left 050524d-214, right 050524d-216))

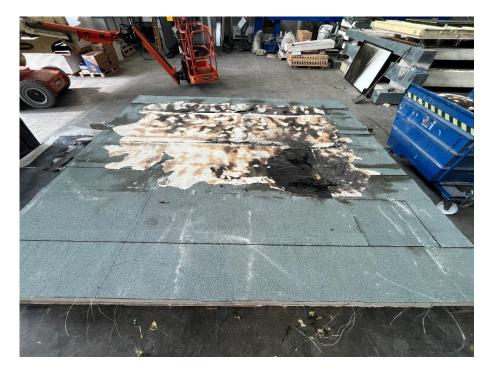
Figure 59 Sample AS-3 Overview of bitumen layer showing residues of the AllShield BarrierSheet under the burning area (FotoPortal 050524d-218)

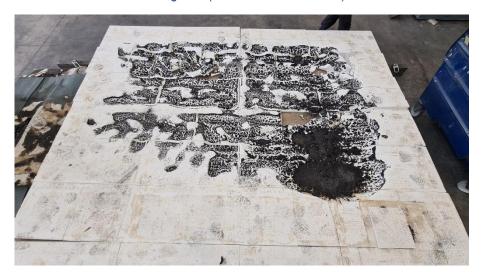
The EPS layer underneath exhibited extensive melting in parts, particularly beneath the areas of highest thermal exposure. As visible in Figure 60, both EPS and bitumen residues were present, indicating damage to the materials by heat. The most severe damage was localised but notable - in one section, the bitumen had completely liquefied and fused with the melted EPS. This fused mass adhered to the plasterboard below, which serves as the structural base layer beneath the roof system (Figure 61).

Figure 60 Sample AS-3 Overview of EPS layer showing melted areas along with bitumen residues (FotoPortal 050524d-220)

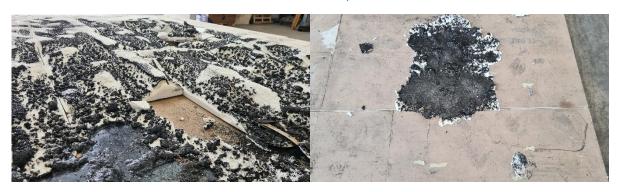
Figure 61 Sample AS-3 A closer look at the EPS area (left) and the fused EPS/bitumen on plasterboard (right) (FotoPortal (left 050524d-222, right 050524d-224))

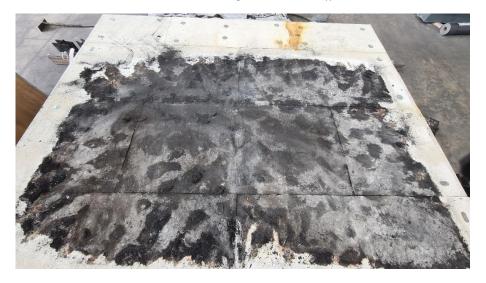
Post-test inspection of the specimen (Figure 62) revealed the condition of the layers beneath the PV modules. The AllShield BarrierSheet showed some gaps between joints (Figure 63 and Figure 64) but largely maintained its shape.

Figure 63 Sample AS-4 Overview of the AllShield BarrierSheet after the test (FotoPortal 050524d-230)

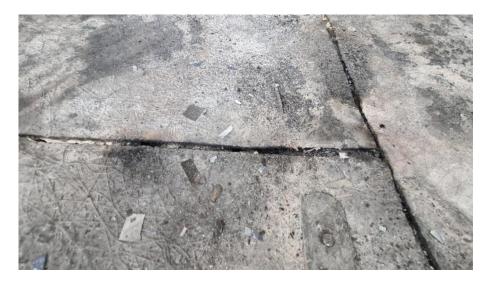
Figure 64 Sample AS-4: A closer look at the AllShield BarrierSheet gap between joints after the test (FotoPortal 050524d-232)

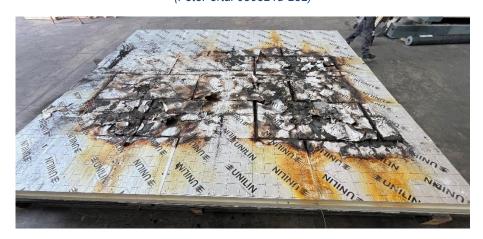
Damage to the PIR insulation layer (Figure 65) was evident beneath the burned area, with a distinctive yellow-brown deposit visible outside the main fire zone, consistent with residues observed in earlier tests.

Figure 65 Sample AS-4 Overview of PIR layer showing damage under the burnt area and yellow-brown deposit outside of the burned area (FotoPortal 050524d-234)

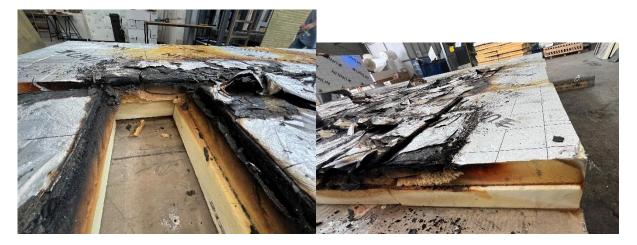
A side view of the PIR board joints (Figure 66) demonstrates that, unlike the previous test with 60 mm thick PIR boards (AS-2), the thicker 120 mm PIR panels used in this test resisted deformation and heat penetration more effectively. The damage extended approximately halfway through the board's depth, with visible discolouration through most of the thickness, but without actual structural collapse of the boards. The upper aluminium foil layer was damaged similarly to the previous test, showing burn-through in the regions exposed to fire.

Figure 66 Sample AS-4 Side view of PIR board joints in two locations, with the most severe burns (left and right) showing that the damage did not manage to penetrate to the underside of PIR at any point (FotoPortal (left 050524d-236, right 050524d-238))
