# Additional test report

Allshield Blue 2C coating + EKLTM 800 /  
450 reinforcement / Eco Prim Grip primer / Cosmofin FG /  
Fisprofi 5,0 × 120 mm fastener + Ø 70 metal washer /  
Unidek Platinum Kameleon / trapezoidal steel deck

test on external fire exposure to roofs  
in combination with photovoltaic (PV)  
arrays according to the principles of  
CLC/TR 50670

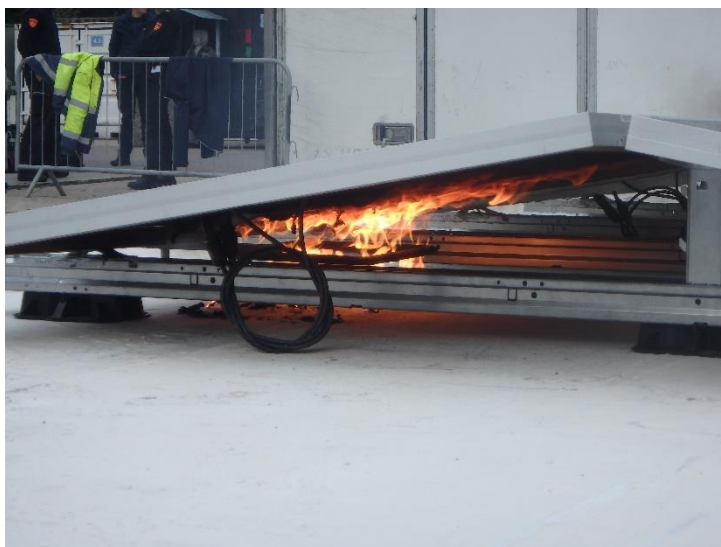
## Photo 3

The PV module is burning.

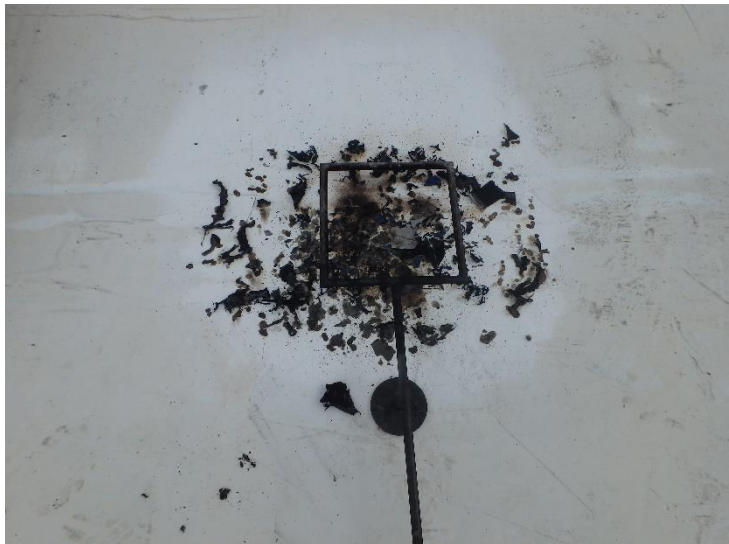
The coating did not catch fire so there was no spread of fire on the surface of the test specimen.

**Photo 5**  
Overview of the damaged area of the coating.

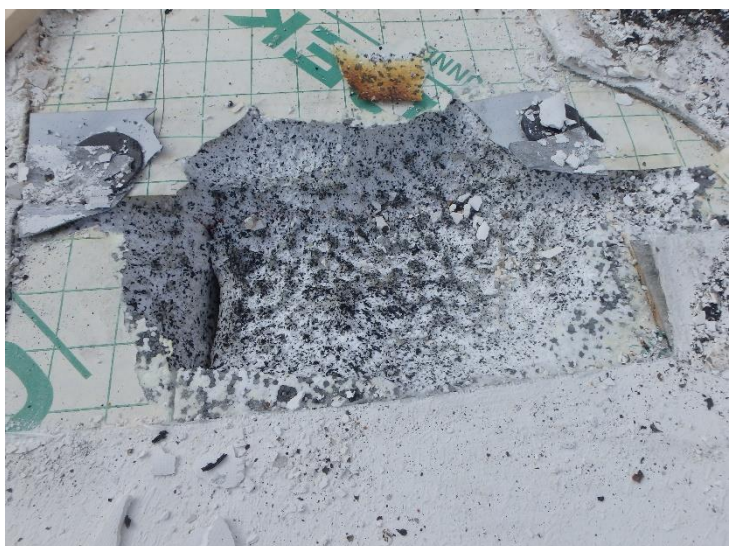
The burner has been turned off after 10:00 (min:s); the flames were directly gone. After 15 minutes the temperature has reached 135 °C in the middle of the insulation, after this time the temperature decreased.

**Photo 6**  
Overview of the damaged area of the thermal insulation.
